LPC 0850260920 Jo Daviess County
Jo Daviess Service Company
ST/IRS

CERCLA Integrated Site Assessment

**Illinois Environmental
Protection Agency**

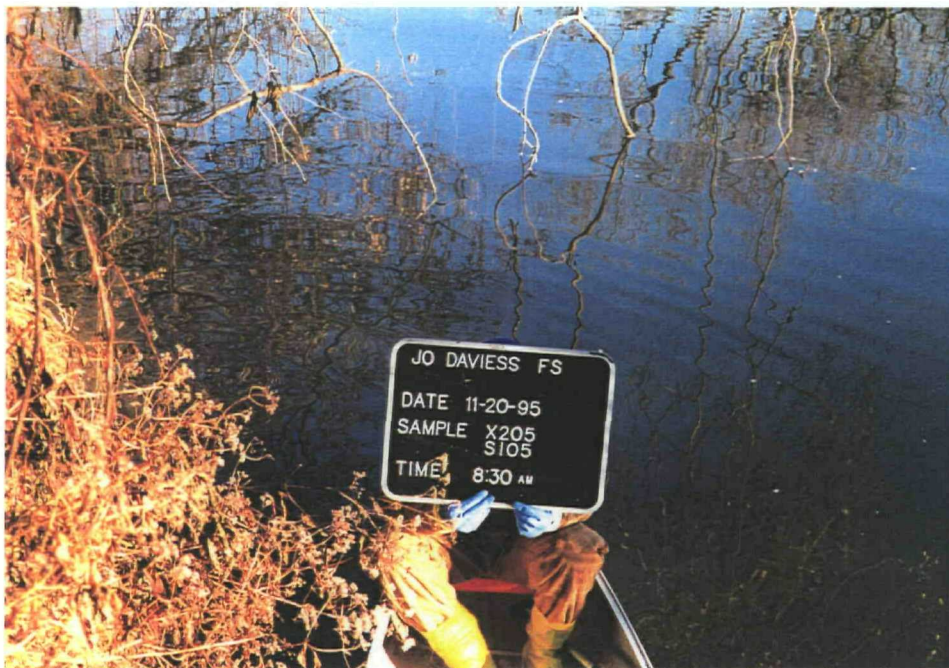
COMMENTS: Photo taken of sample
points X205 and S105 along the west
shore of the Galena River south of the
Jo Daviess Service Co. property

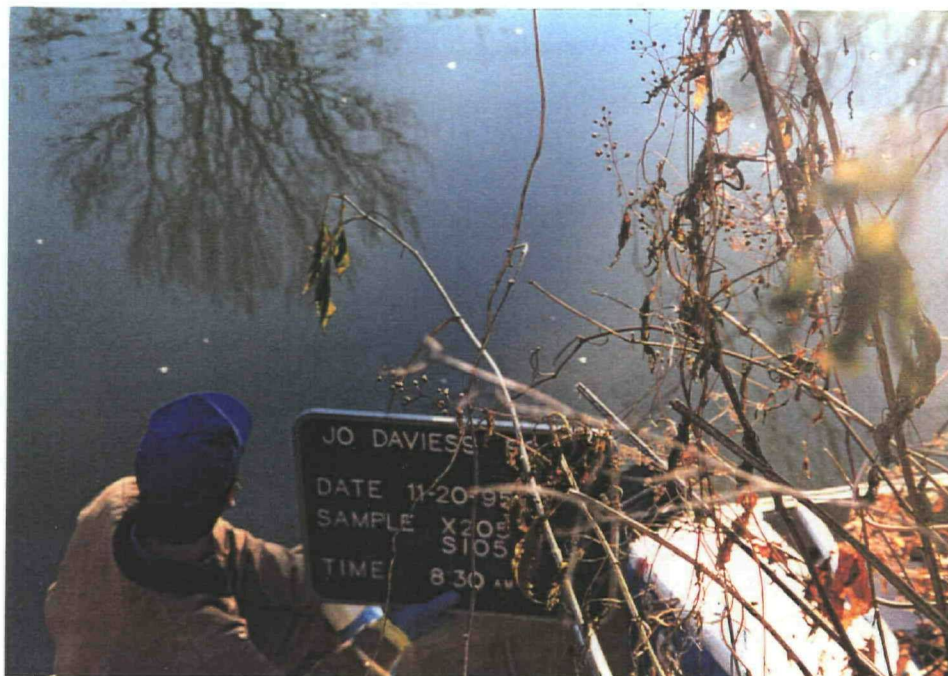
COMMENTS: Photo taken of sample
points X205 and S105 along the west
shore of the Galena River south of the
Jo Daviess Service Co. property

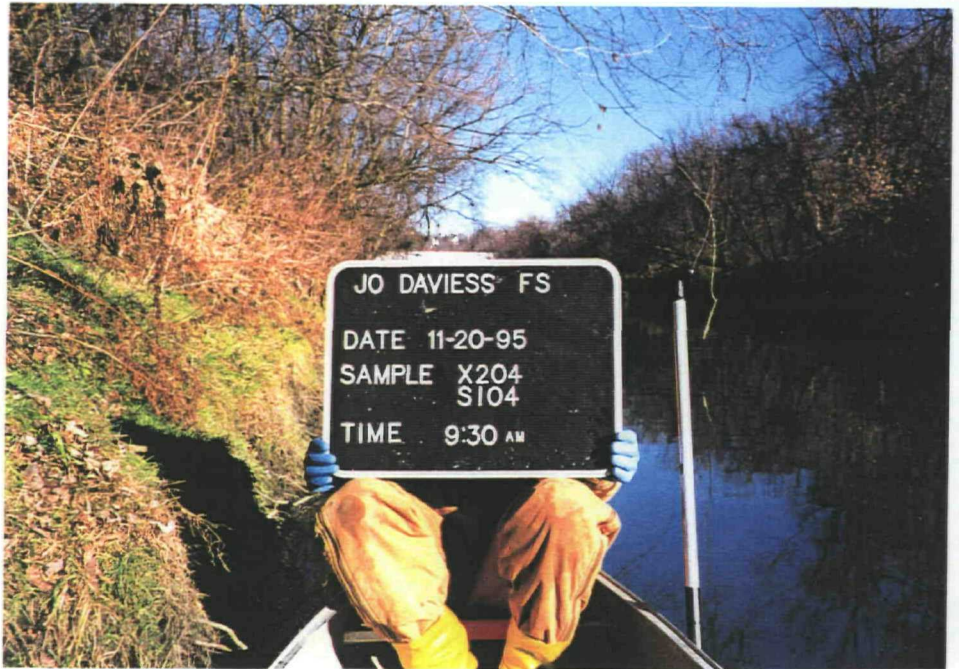
COMMENTS: Photo taken of sample
points X204 and S104 along the west
shore of the Galena River south of the
Jo Daviess Service Co. property

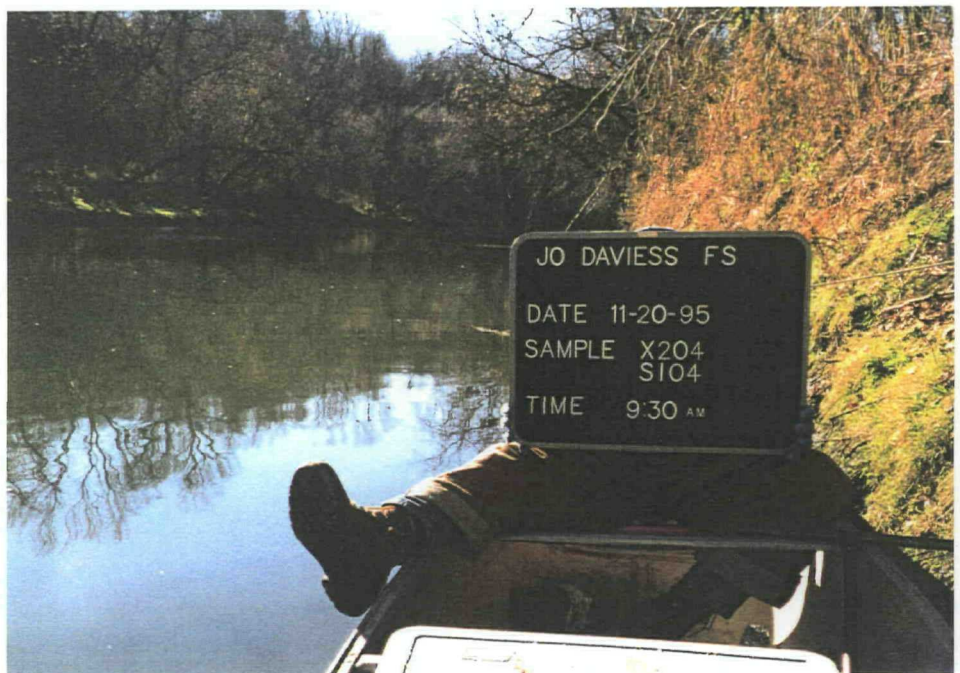
COMMENTS: Photo taken of sample
points X204 and S104 along the west
shore of the Galena River south of the
Jo Daviess Service Co. property

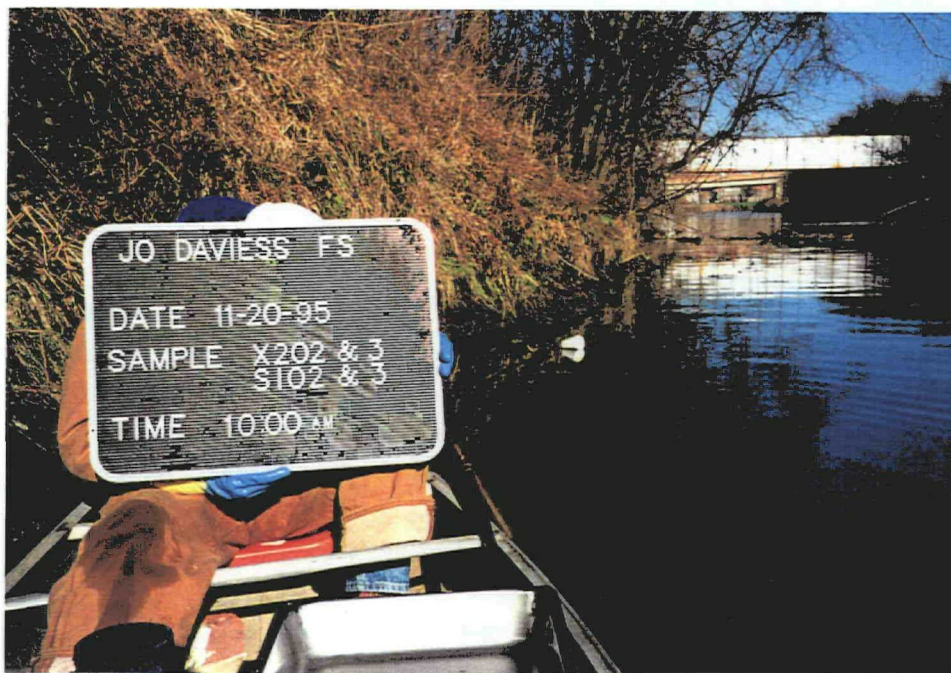
COMMENTS: Photo taken of sample
point X202/X203 and S102/S103 along
the west shore of the Galena River east
of the Jo Daviess Service Co. property

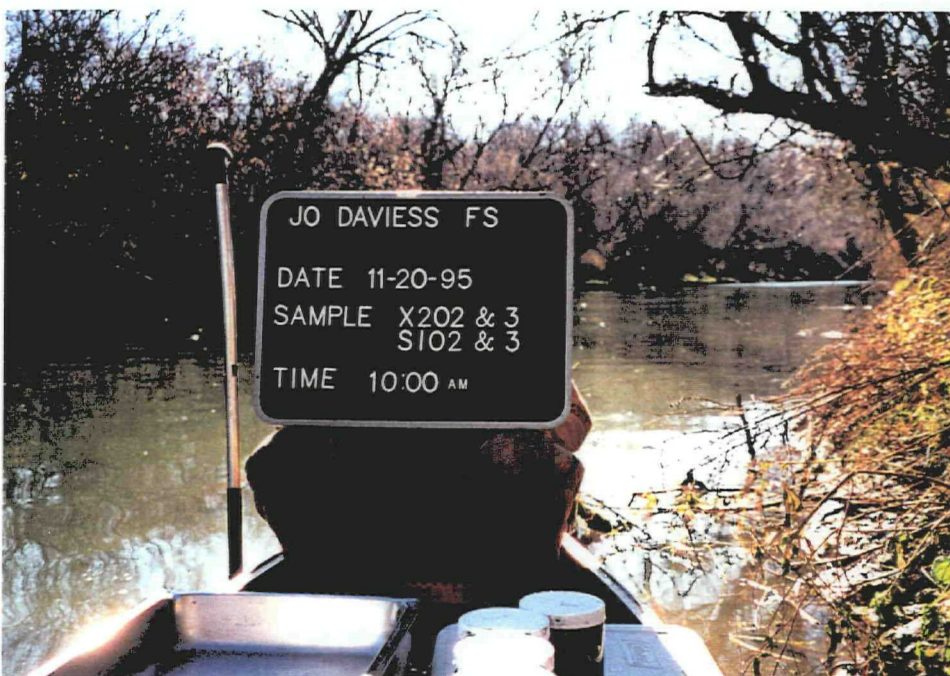
COMMENTS: Photo taken of sample
point X202/X203 and S102/S103 along
the west shore of the Galena River east
of the Jo Daviess Service Co. property

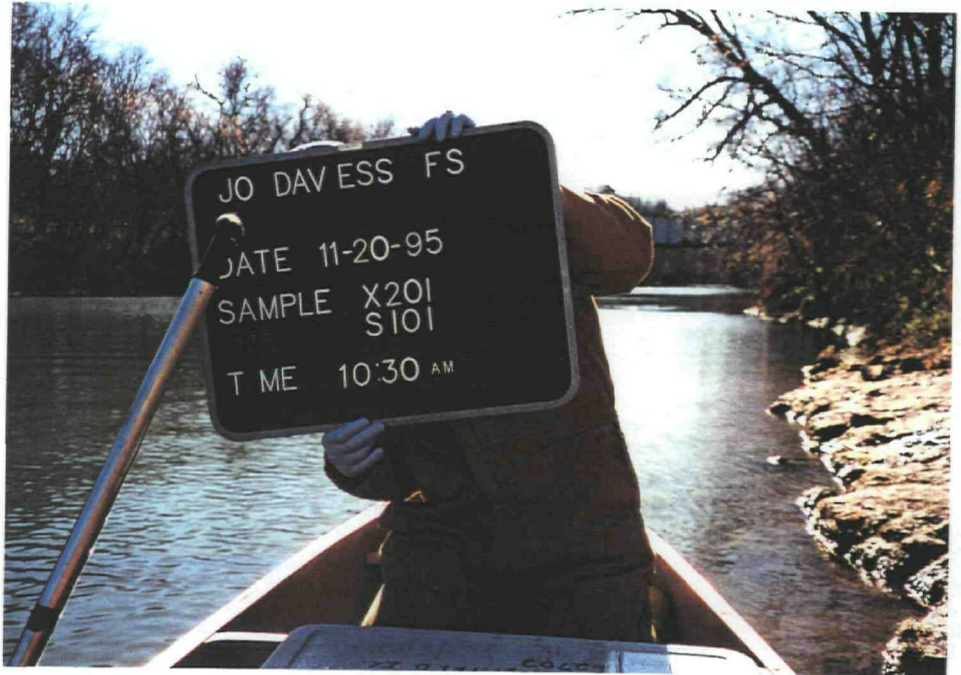
COMMENTS: Photo taken of sample
point X201 and S101 along the west
shore of the Galena River north of the
Jo Daviess Service Co. property

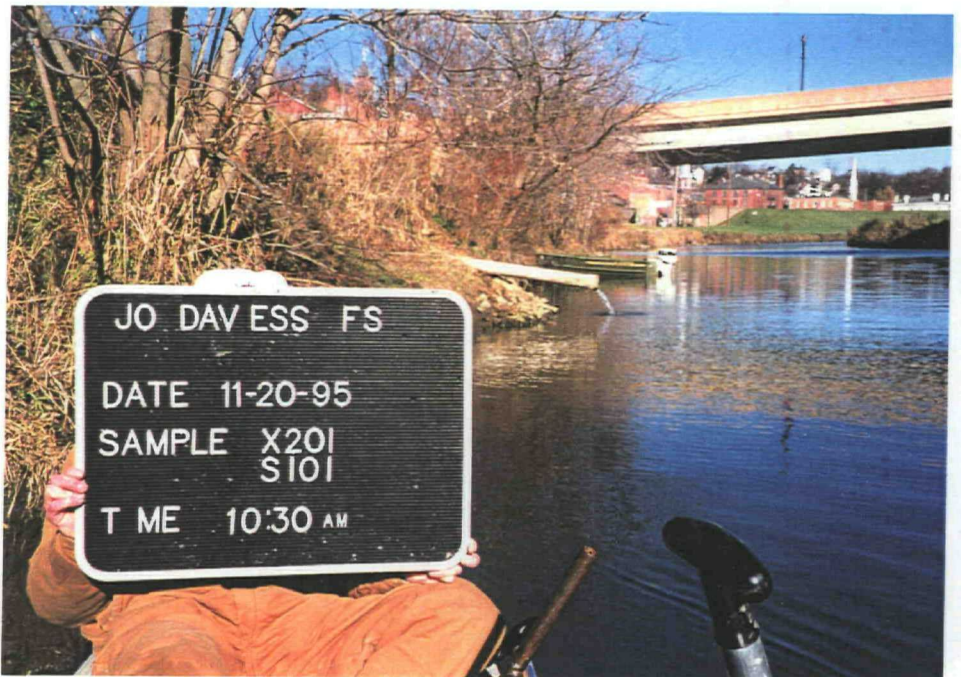
COMMENTS: Photo taken of sample
point X201 and S101 along the west
shore of the Galena River north of the
Jo Daviess Service Co. property

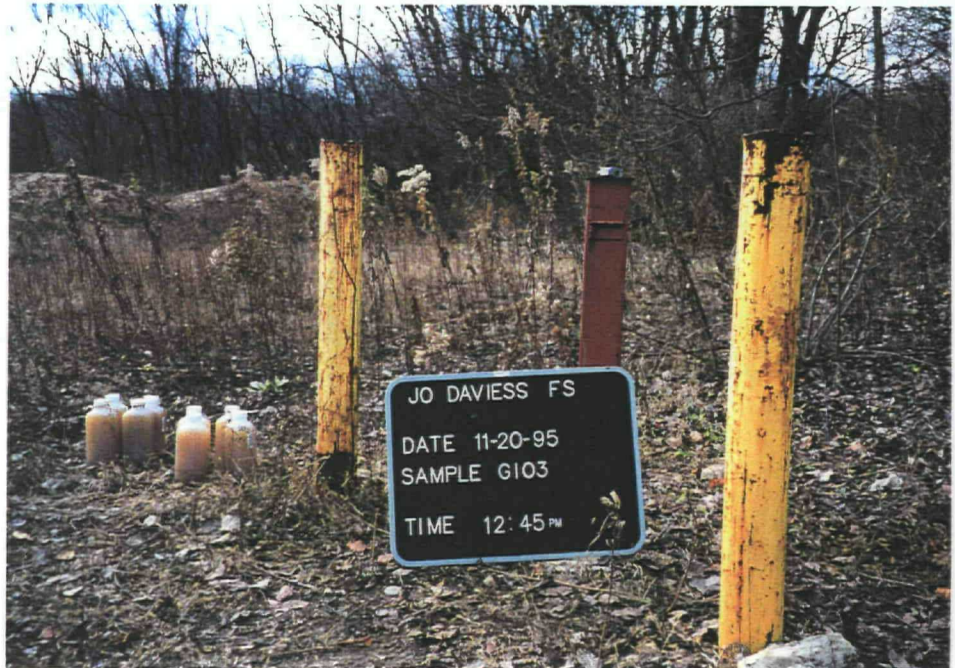
COMMENTS: Photo taken of sample
point G103 located at Monitor Well #3
found along the northeast portion of
the Jo Daviess Service Co. property

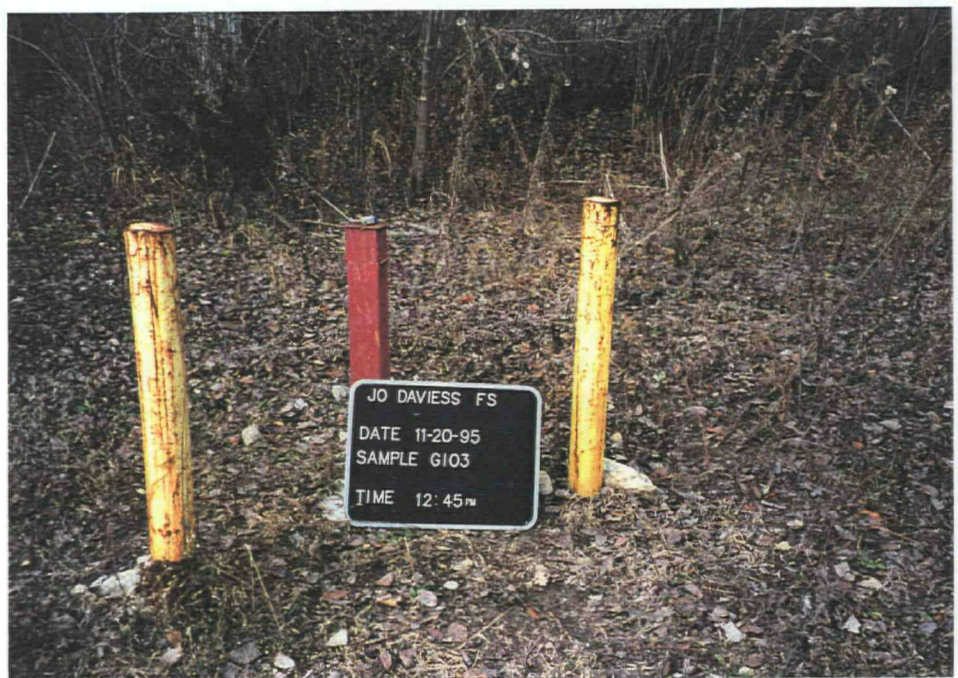
COMMENTS: Photo taken of sample
point G103 located at Monitor Well #3
found along the northeast portion of
Jo Daviess Service Co. property

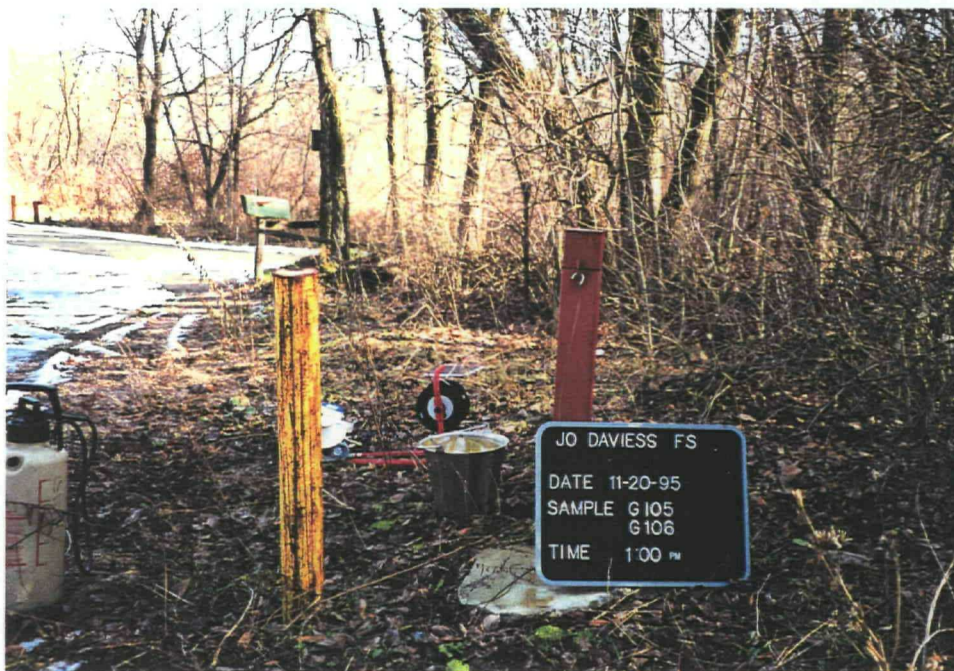
COMMENTS: Photo taken of sample
point G105 & G106 (duplicate)

located at Monitor Well #5 along the
southern portion of the JDSC property

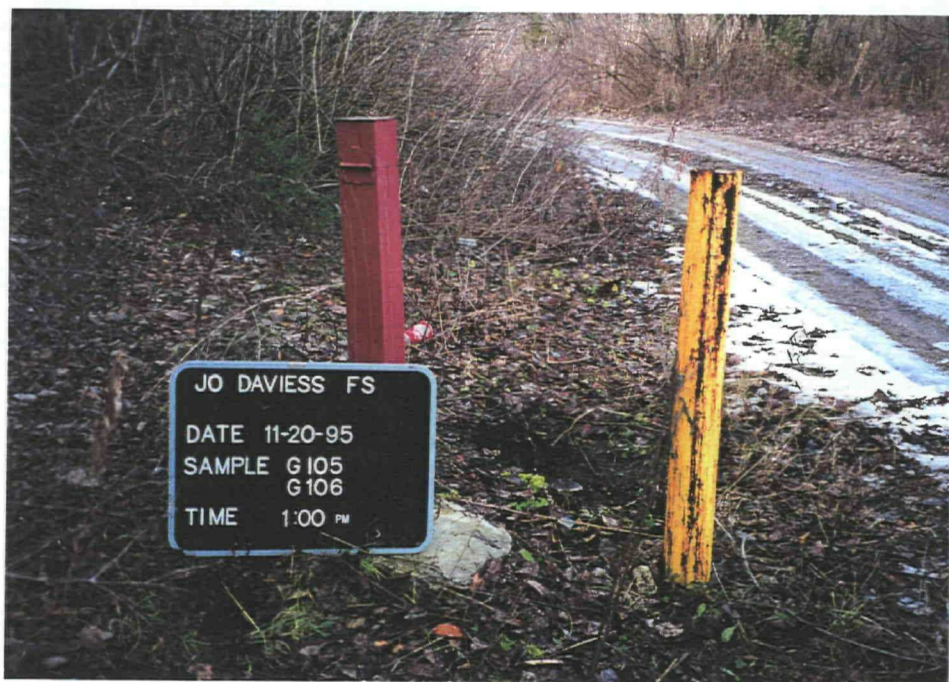
COMMENTS: Photo taken of sample
point G105 & G106 (duplicate)

located at Monitor Well #5 along the
southern portion of the JDSC property

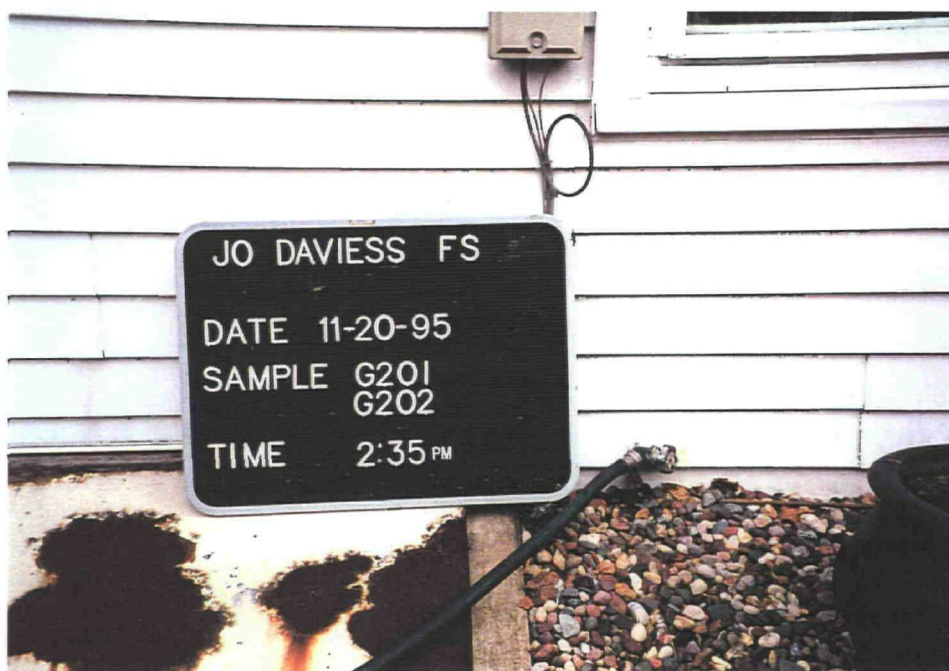
COMMENTS: Photo taken of sample
point G201 & G202 (duplicate)

located at a residential well south of
the Jo Daviess Service Co. property

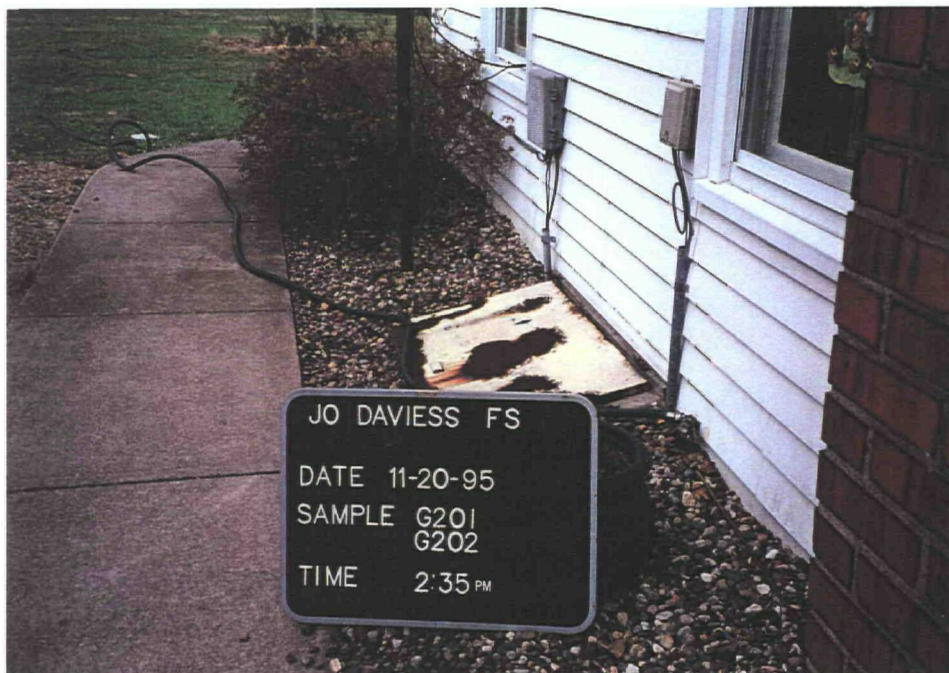
COMMENTS: Photo taken of sample
point G201 & G202 (duplicate)

located at a residential well south of
the Jo Daviess Service Co. property

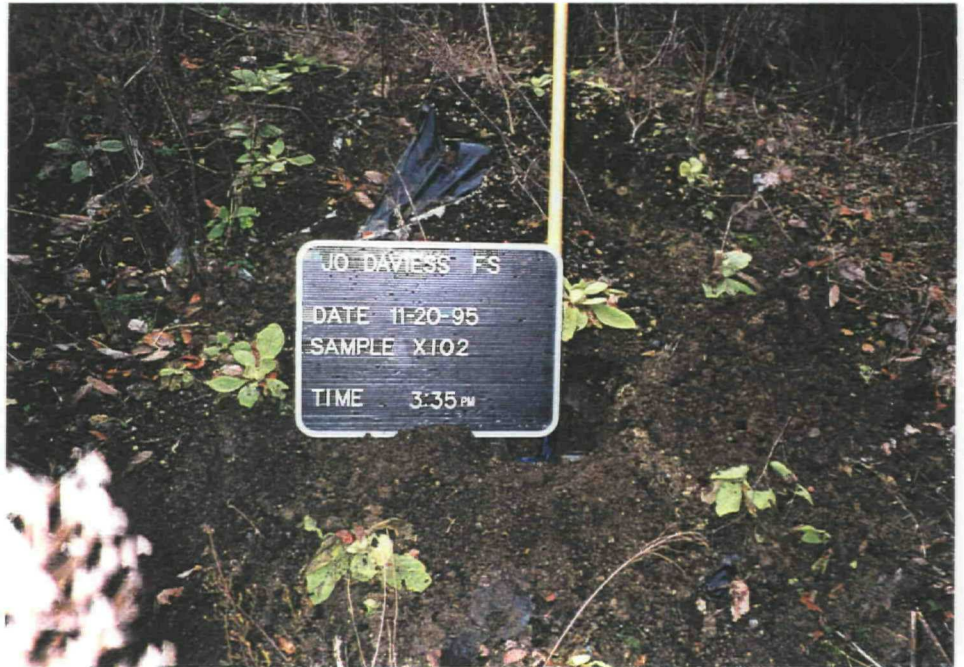
Sample X102 was located 42 feet north of an east-west gravel road and 67 feet north of monitor well 5. This sample was located along the northern slope of a pile of excavated soil situated along the southern portion of the JDSC property. The pile of soil was a result of the 1993 remedial activities performed by DAHL. The purpose of obtaining this sample was to determine if contamination existed within the contents of the wastepile. The sample was obtained using a stainless steel trowel, from a depth of 1 ½ - 2 feet. The sample appearance was a dark brown/black urban fill.

COMMENTS: Photo taken of sample
point X102 collected from the north
side of a pile of excavated soil within
the Jo Daviess Service Co. property

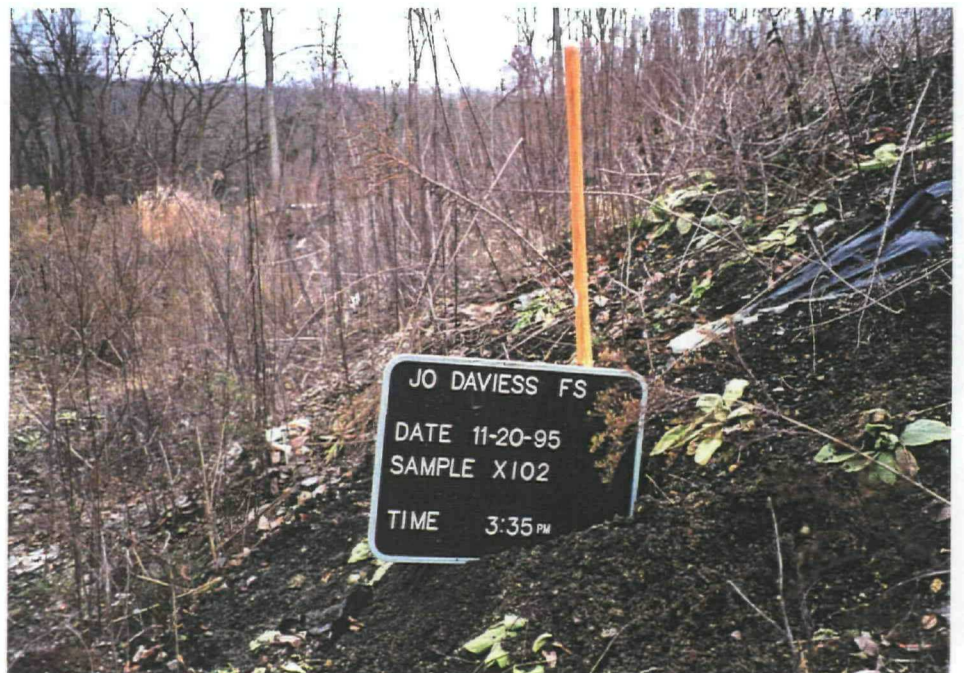
COMMENTS: Photo taken of sample
point X102 collected from the north
side of a pile of excavated soil within
the Jo Daviess Service Co. property

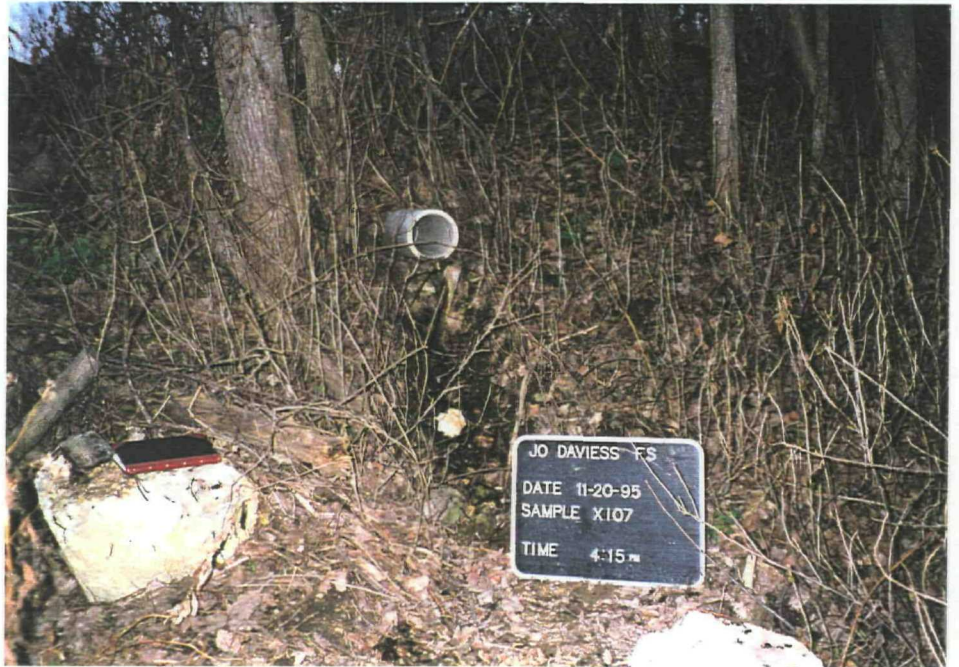
Sample X107 was located 12 feet east of South Water Street in direct line with a drainage pipe beneath the street. The drainage pipe was sloped toward the east, thus providing a route for excess surface water and sediments from the JDSC property to be carried toward the Galena River. At the time of sample collection, a small amount of water was flowing from the drainage pipe. The sample was obtained using a stainless steel trowel from 1 - 5 inches below the surface. The appearance of the sample was a dark brown silty loam containing small pieces of gravel.

COMMENTS: Photo taken of sample
point X107 located beneath a drainage
pipe east of the Jo Daviess Service Co.
property

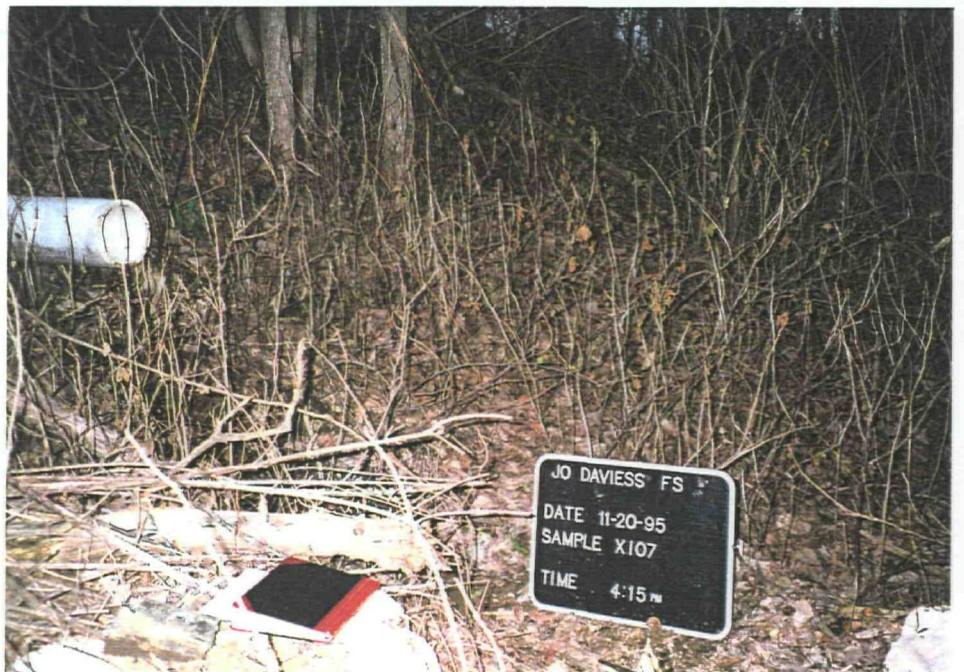
COMMENTS: Photo taken of sample
point X107 located beneath a drainage
pipe east of the Jo Daviess Service Co.
property

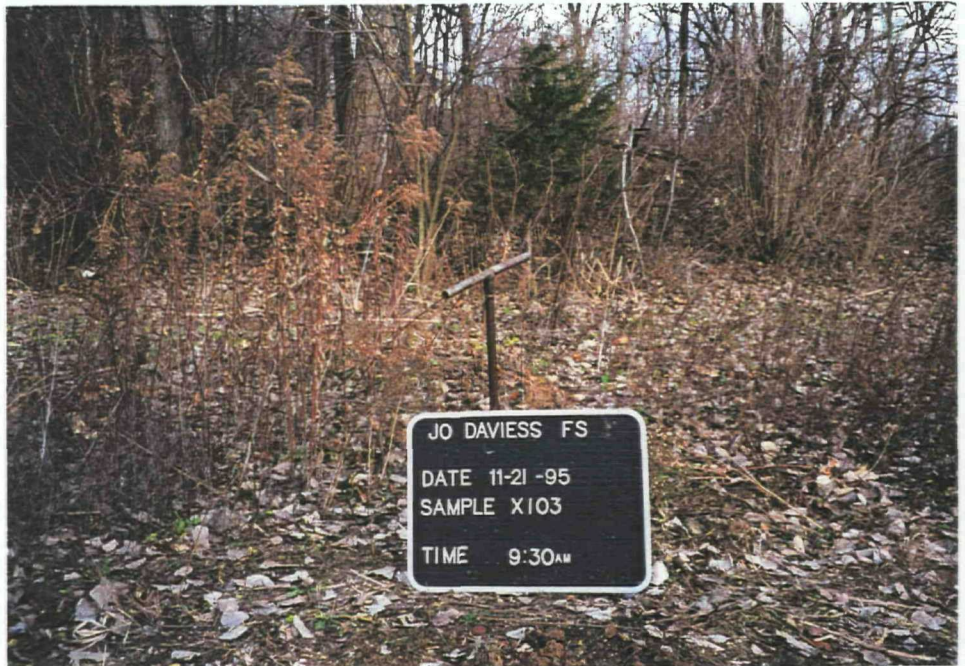
Sample X103 was located 60 feet southwest of monitor well 3 and 50 feet southeast of monitor well 2 along the eastern portion of the JDSC property. The area was located near the previous location of the bulk petroleum storage tanks. The sample was collected to determine if contamination existed in the upper two feet of soil. Using a stainless steel auger, the sample was taken in the 1 ½ - 2 foot range of soil. Appearance of the sample was a dark brown cindery, silty clay. Beneath the 2 foot range, the soil became cluttered with bricks, metal, and other debris.

COMMENTS: Photo taken of sample
point X103 located along the east
portion of the Jo Daviess Service Co.
property

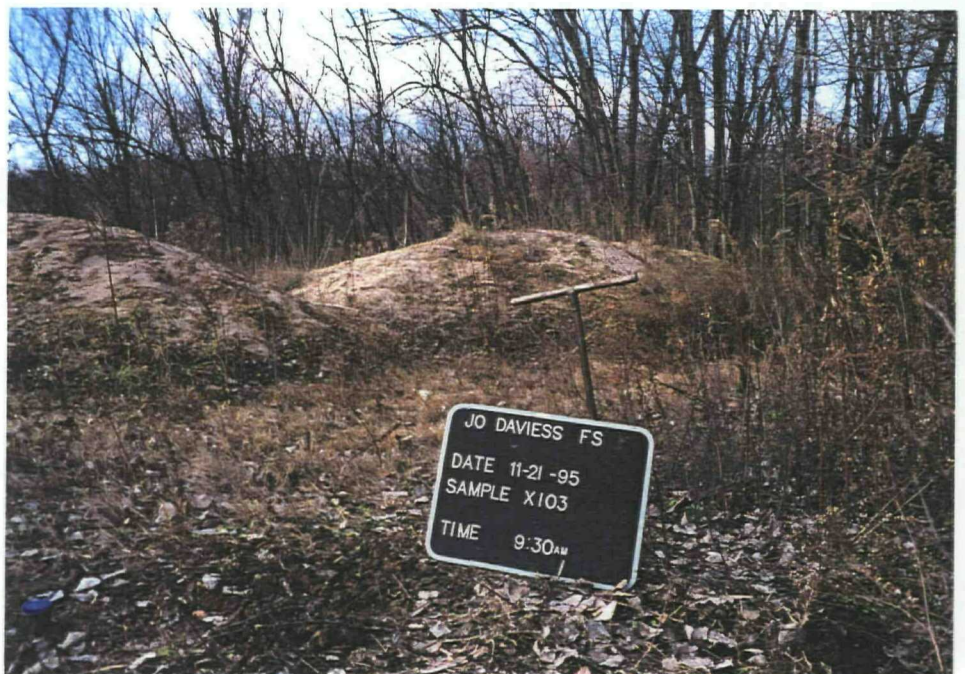
COMMENTS: Photo taken of sample
point X103 located along the east
portion of the Jo Daviess Service Co.
property

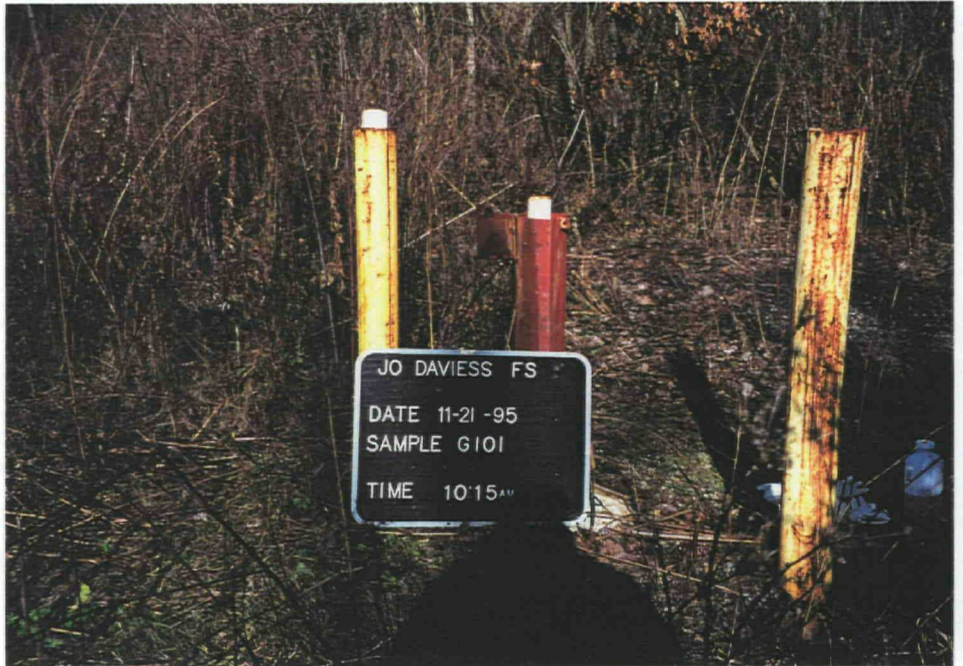
COMMENTS: Photo taken of sample
point G101 (background) located at
Monitor Well #1 found along the west
portion of the JDSC property

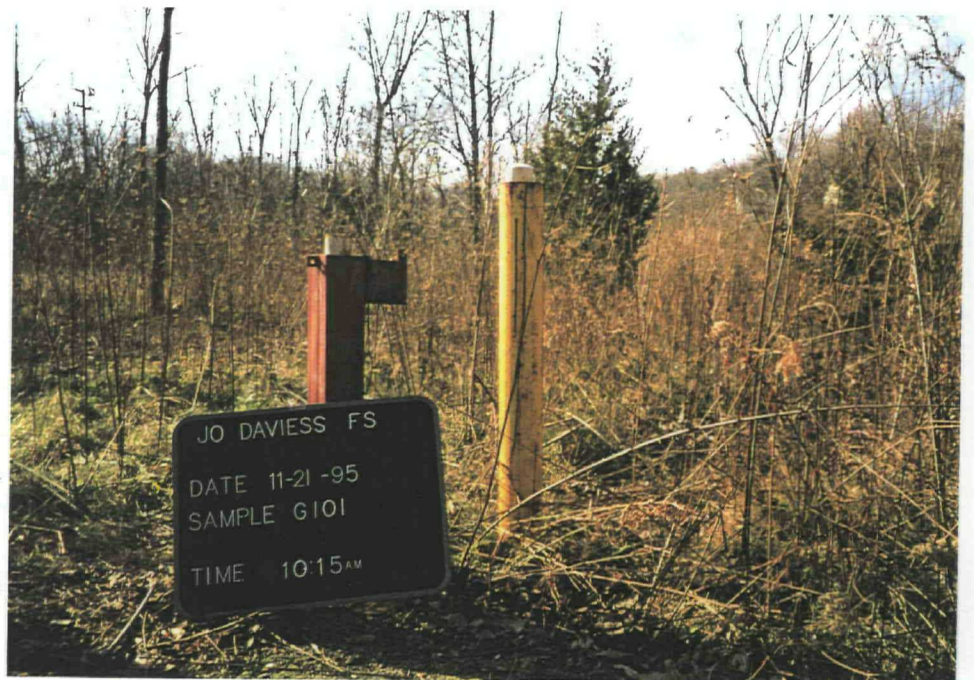
COMMENTS: Photo taken of sample
point G101 (background) located at
Monitor Well #1 found along the west
portion of the JDSC property

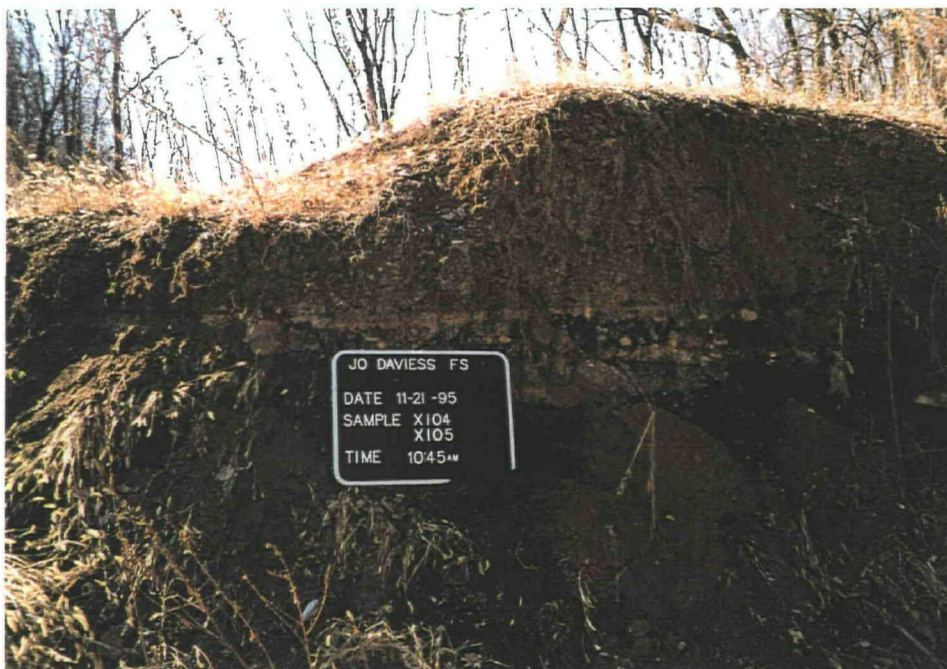
excavated pit on the JDSC property. From the wall of the pit, the sample was collected in order to determine if contamination existed within the pit. A stainless steel trowel was used to obtain a sample at a depth of 1 - 1 ½ feet. The sample appeared to contain a black cindery loam with pieces of orange brick.

COMMENTS: Photo taken of sample
point X104/X105 (duplicate) along
western wall of the excavated pit on
the Jo Daviess Service Co. property

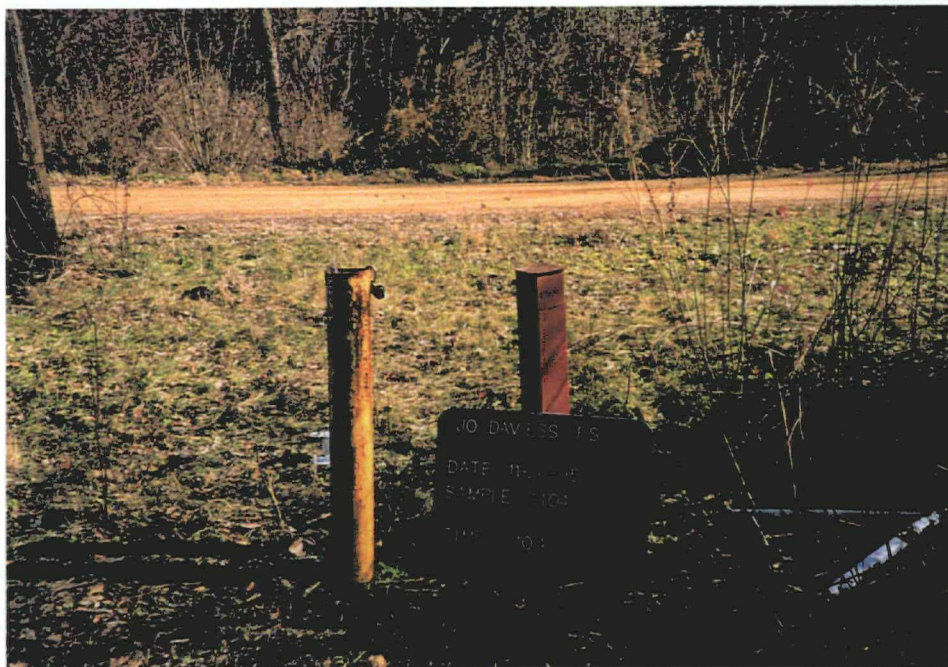
COMMENTS: Photo taken of sample
point G104 located at Monitor Well #4
found along the southeast portion of
the Jo Daviess Service Co. property

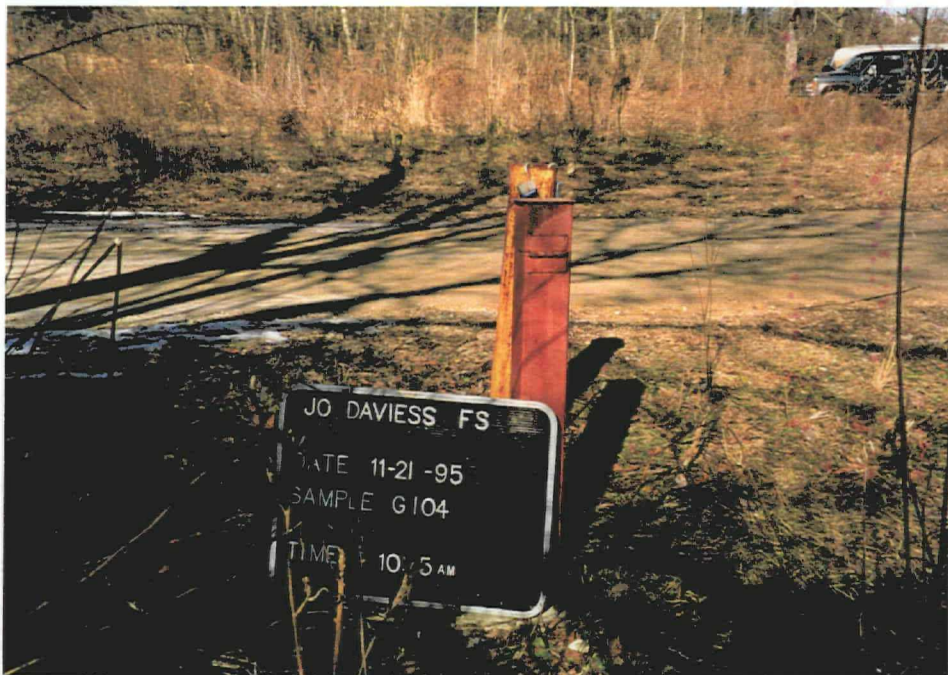
COMMENTS: Photo taken of sample
point G104 located at Monitor Well #4
found along the southeast portion of
the Jo Daviess Service Co. property

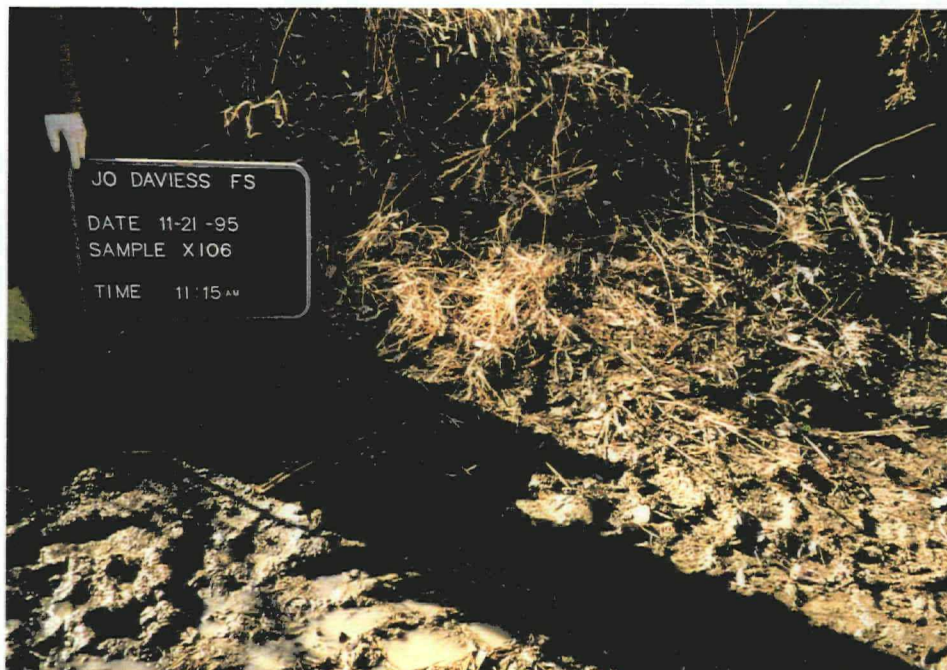
Sample X106 was located 42 feet southwest of monitor well 2 and 102 feet north of monitor well 5 in the bottom of the excavated pit. The excavated pit was approximately 6 to 8 feet below the surrounding terrain at this sample location. The sample was obtained at a depth of 1 - 1 ½ feet into the bottom of the pit using a stainless steel auger. Air monitoring of the sample revealed a reading of 1200 ppm on the flame ionization detector. The sample had an appearance of a dark brown sandy clay.

COMMENTS: Photo taken of sample
point X106 located at the bottom of the
excavated pit found on the Jo Daviess
Service Co. property

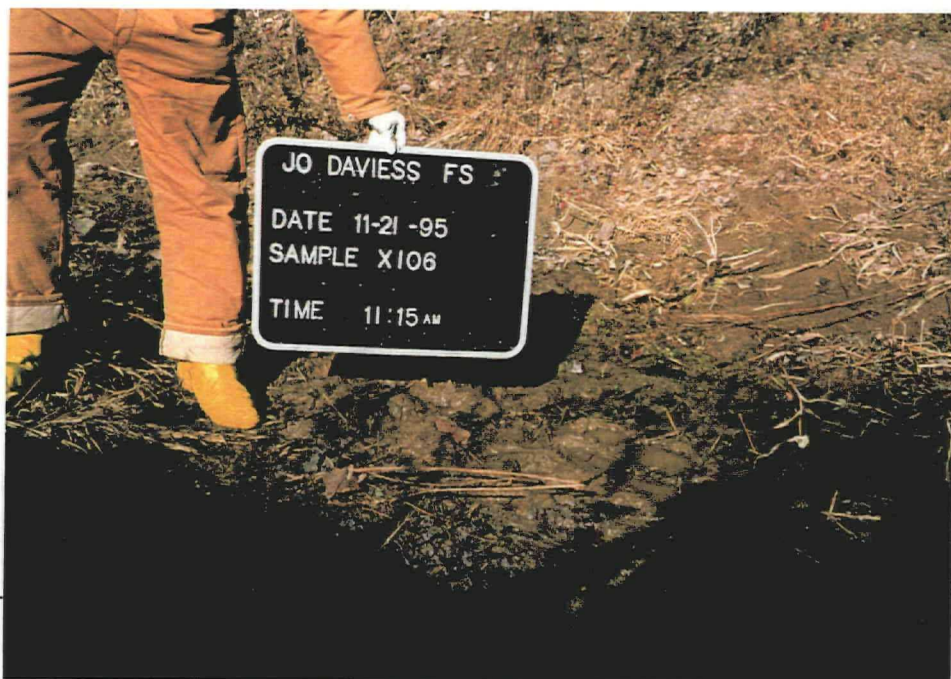
COMMENTS: Photo taken of sample
point X106 located at the bottom of the
excavated pit found on the Jo Daviess
Service Co. property

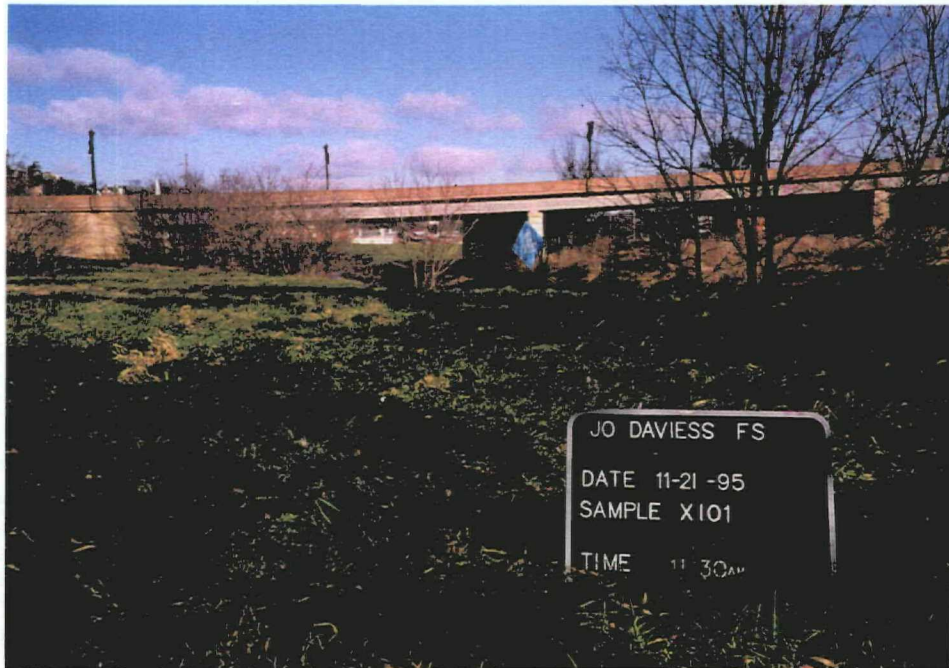
COMMENTS: Photo taken of sample
point X101 (soil background) located
north of the Jo Daviess Service Co.
property

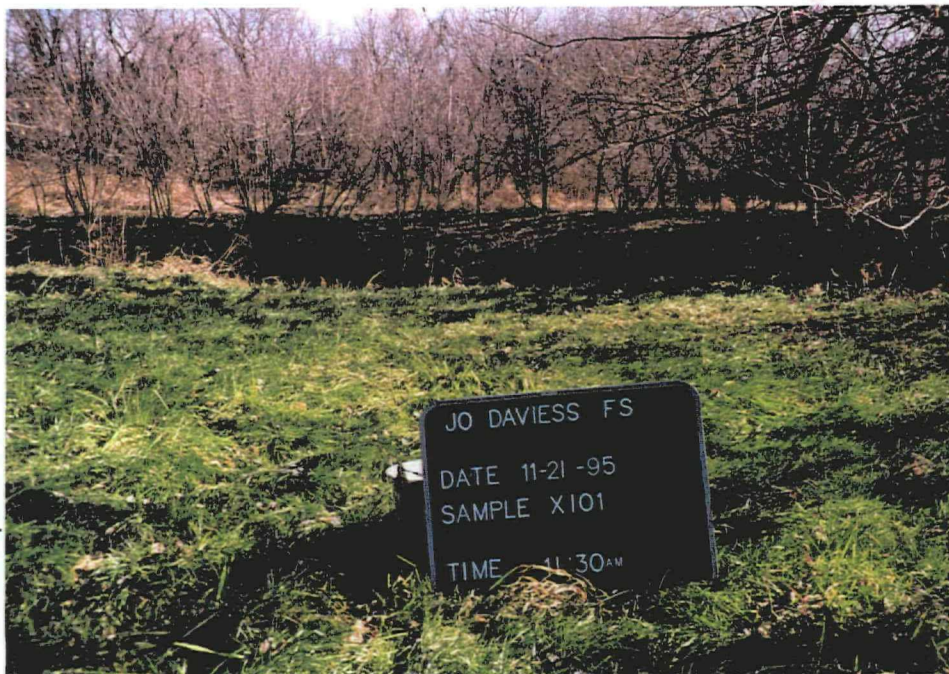
COMMENTS: Photo taken of sample
points X101 (soil background) located
north of the Jo Daviess Service Co.
property
